**Flood Control Project Maintenance
Levee Inspections**

Maintenance Issue Types Only, Levee Inspection Report By Mile - Spring 2018

Reclamation District No. 2089 Stark

Waterway	Bank	Unit Miles	Inspection Start/End	Inspector
Unit No. 01 Old River	Right	1.51	05/15/2018 05/15/2018	Zach Jojola

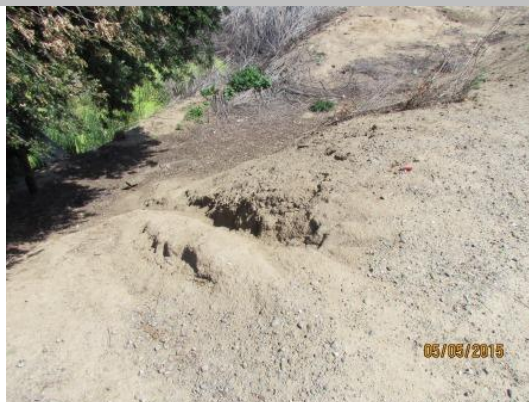
Photo 1 of 1 : SP_2018_RD2089_316_1_20180507_00001.jpg

View of the stairs eroding into the landside levee slope.

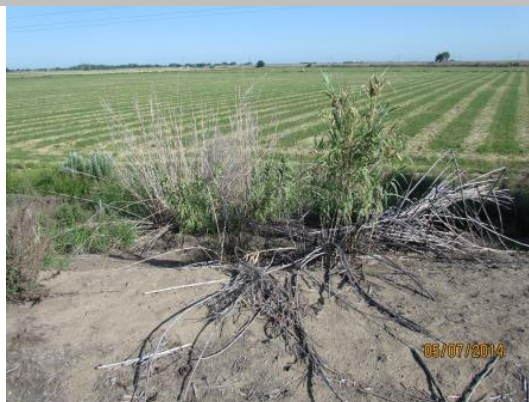
Photo 1 of 1 : SP_2018_RD2089_316_940_20180507_00042.jpg

LM Start	0.24	Rating **	M	Issue No.	940
LM End	0.24	Issue Type +	Ma	Location *	LS
Category	Earthen Levee			GPS Latitude/Longitude	
				Start	End
Item	Vegetation			37.810412 °	37.810412 °
				-121.389115 °	-121.389115 °
DWR ID	DWR_RD2089_01_s_2012_940				
Comment Code					
V2 : Remove the wild growth other than native grasses from the levee slopes.					
Inspector Comment					
Arundo has been trimmed back from the crown but still remains as an obstruction to the slope and obstructs visibility, needs to be removed.

The LMA is actively trying to remove the vegetation on the landside levee slope and toe.

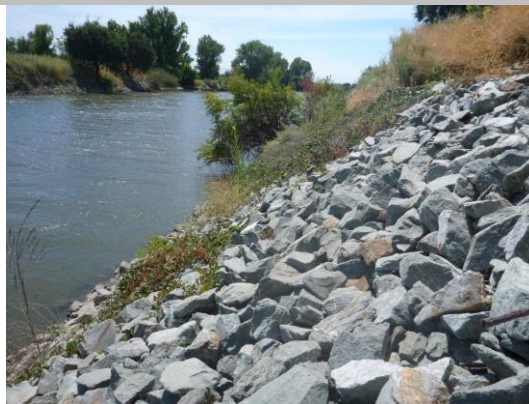
Photo 1 of 2 : LEVAL_SP_2018_513_4443.jpg

LM Start	0.26	Rating **	M	Issue No.	13
LM End	0.27	Issue Type +	Ma	Location *	
Category	Supplemental			GPS Latitude/Longitude	
				Start	End
Item	2017 Storm Damage			37.810300 °	37.810300 °
				-121.389300 °	-121.389500 °
DWR ID	DWR_RD2089_01_f _ 2017_13				
Comment Code					
Inspector Comment					
Levee Evaluation Comments					
Description:Slope protection repairs are needed along the waterside slope due to erosion and riprap displacement from high water. Based upon levee inspections, it was determined the waterside levee slope is eroding, deteriorating, and degrading. The eroded levee sections need to be restored back to design standards to prevent further deterioration and damage.					
Site ID No:513					
Site Designation:LMA-419					
Repair Type: Erosion					
Rating:Area of Concern					
Field Date:8/14/2017					
Notes: Small erosion at toe.

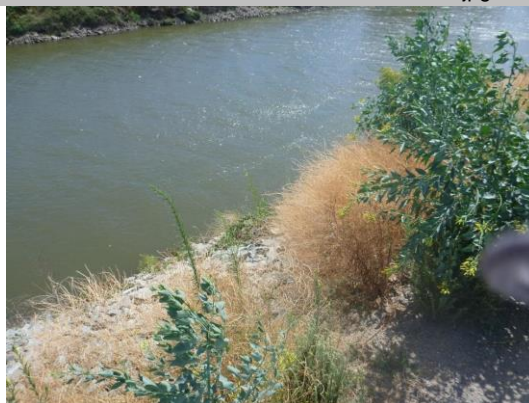
Photo 2 of 2 : LEVAL_SP_2018_513_4448.jpg

LM Start	0.26	Rating **	M	Issue No.	13 (cont)
LM End	0.27	Issue Type +	Ma	Location *	
Category	Supplemental			GPS Latitude/Longitude	
				Start	End
Item	2017 Storm Damage			37.810300 °	37.810300 °
				-121.389300 °	-121.389500 °
DWR ID	DWR_RD2089_01_f_2017_13				
Comment Code					
Inspector Comment					
Levee Evaluation Comments					
Description:Slope protection repairs are needed along the waterside slope due to erosion and riprap displacement from high water. Based upon levee inspections, it was determined the waterside levee slope is eroding, deteriorating, and degrading. The eroded levee sections need to be restored back to design standards to prevent further deterioration and damage.					
Site ID No:513					
Site Designation:LMA-419					
Repair Type: Erosion					
Rating:Area of Concern					
Field Date:8/14/2017					
Notes: Small erosion at toe.

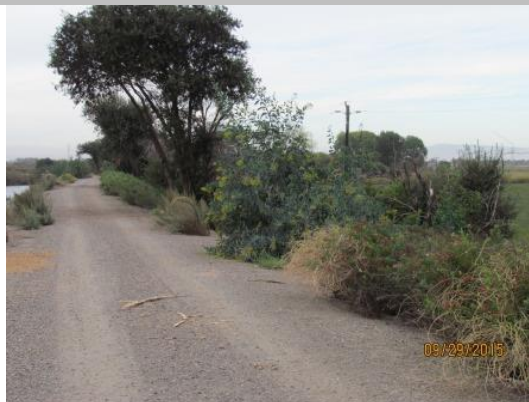
Photo 1 of 1 : SP_2018_RD2089_316_12_20180507_00010.jpg

LM Start	0.27	Rating **	U	Issue No.	12
LM End	0.39	Issue Type +	Ma	Location *	LS
Category	Earthen Levee			GPS Latitude/Longitude	
				Start	End
Item	Vegetation			37.810319 °	37.809740 °
				-121.389510 °	-121.391645 °
DWR ID	DWR_RD2089_01_s_2012_12				
Comment Code					
V2 : Remove the wild growth other than native grasses from the levee slopes.					
Inspector Comment					
Access and visibility completely blocked. 11/10/2011 issue has not changed.

Thick brush and wild rose completely block access and visibility of landside slope and toe.

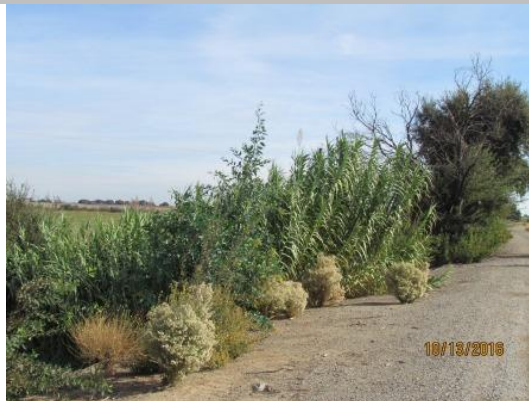
Photo 1 of 2 : SP_2018_RD2089_316_19_20180507_00017.jpg

View of the arundo back on the landside levee slope. Fall 2016

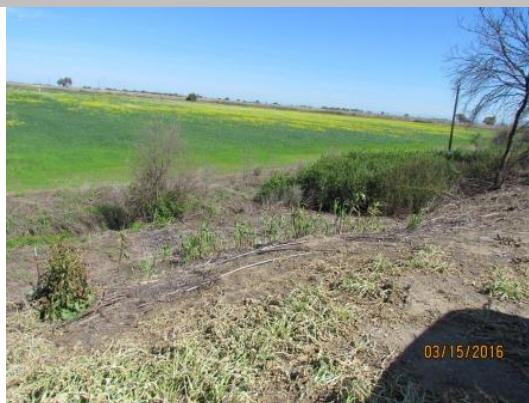
Photo 2 of 2 : SP_2018_RD2089_316_19_20180507_00018.jpg

Arundo was trimmed back from the road and needs to be maintained so that it does not obstruct visibility and access to the landside toe.

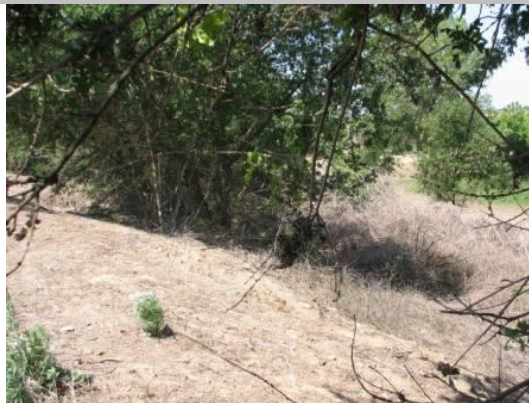
Photo 1 of 1 : SP_2018_RD2089_316_28_20180507_00028.jpg

05/24/2011 Photo shows thick dead vegetation and continuation of trees in area that are preventing access and visibility of landside slope and toe.

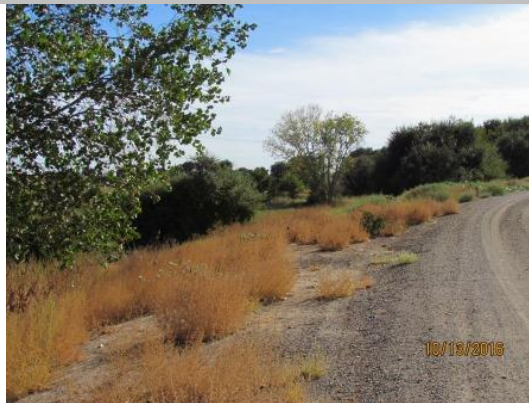
Photo 1 of 1 : SP_2018_RD2089_316_27_20180507_00027.jpg

View of the vegetation on the landside levee slope.

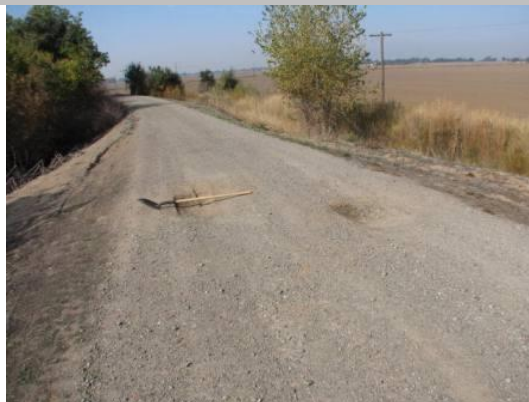
Photo 1 of 1 : SP_2018_RD2089_316_14_20180507_00013.jpg

LM Start	0.54	Rating **	M	Issue No.	14
LM End	0.54	Issue Type +	Ma	Location *	CR
Category	Earthen Levee			GPS Latitude/Longitude	
				Start	End
Item	Crown Surface / Depressions / Rutting			37.810087 °	37.810087 °
				-121.394200 °	-121.394200 °
DWR ID	DWR_RD2089_01_s_2012_14				
Comment Code					
C3 : Add appropriate gravel or road base. Grade and compact.					
Inspector Comment					
11/10/2011 Minor depressions will cause ponding.

11/10/2011 Depressions in crown.

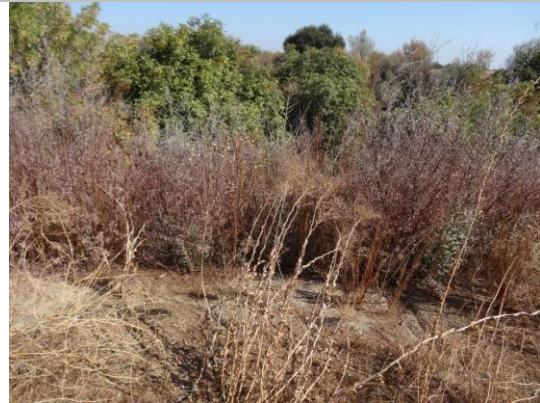
Photo 1 of 2 : SP_2018_RD2089_316_5_20180507_00007.jpg

09/13/2017: No significant change observed.
 07/25/2016: No significant change observed.
 06/25/2015: No significant change observed.
 07/02/2014: No significant change observed.
 08/13/2013: No significant change observed.
 08/07/2012: The site has been visited by boat survey. No significant change observed.
 08/23/2011: The 5-foot vertical scarp shows no significant change from the last year inspection. No new erosion activities observed. Dense white willow trees on site.
 09/07/2010: It was difficult to view the erosion due to the thick Willow thickets and other vegetation at the water line. At the time of the inspection, there were no signs of repair on site. As noted during the last survey, there is a 5-foot vertical scarp along the lower slope that may be subjected to high flow velocities.
 08/05/2010: Recommended for repair, per CLRO; "Erosion of this site may be subjective to rapid rates of erosion."

09/28/2009: No major change observed; 5-foot vertical scarp is immediately downstream of where berm has tapered; site is recommended as local maintenance issue, per CLRO CES Evaluation 2008 Report; Site # is the same as RM29.6, LM0.60; previously rated "U".
 11/05/2008: No change observed; rodent holes on lower slope; wide levee crown. [2017 Site ID:RD2089U01RM29.61]

Front view of the site. The scarp erosion is at the levee slope but is not visible due to the dense vegetation at the site.

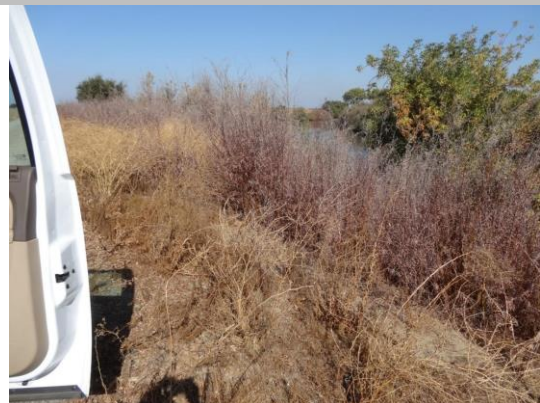
Photo 2 of 2 : SP_2018_RD2089_316_5_20180507_00008.jpg

Front view of the site. Note the very dense white willow thickets on site.

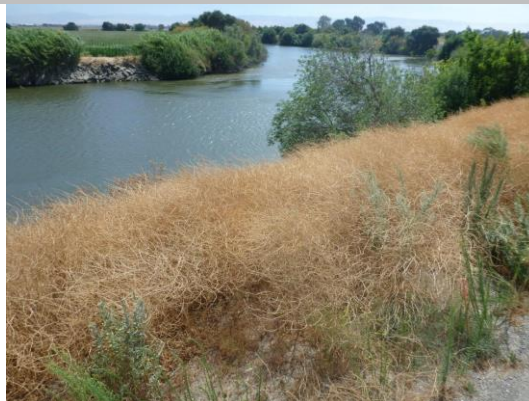
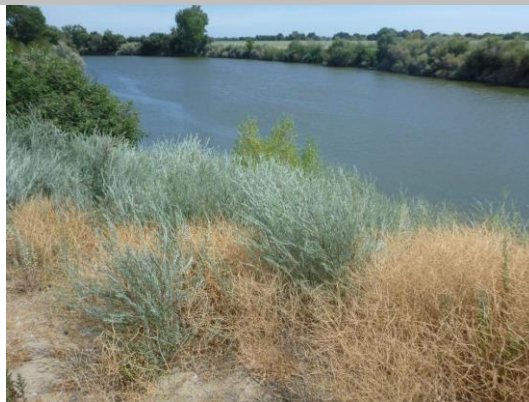
LM Start	0.67	Rating **	A/W	Issue No.	20
LM End	0.68	Issue Type +	Ma	Location *	
Category	Supplemental			GPS Latitude/Longitude	
				Start	End
Item	2017 Storm Damage			37.809700 °	37.809700 °
				-121.396300 °	-121.396400 °
DWR ID	DWR_RD2089_01_f_2017_20				
Comment Code					
Inspector Comment					
Levee Evaluation Comments					
Description:Slope protection repairs are needed along the waterside slope due to erosion and riprap displacement from high water. Based upon levee inspections, it was determined the waterside levee slope is eroding, deteriorating, and degrading. The eroded levee sections need to be restored back to design standards to prevent further deterioration and damage.					
Site ID No:512					
Site Designation:LMA-418					
Repair Type: Erosion					
Rating:Serious					
Field Date:8/14/2017					
Notes: deep erosion more than half way up slope.

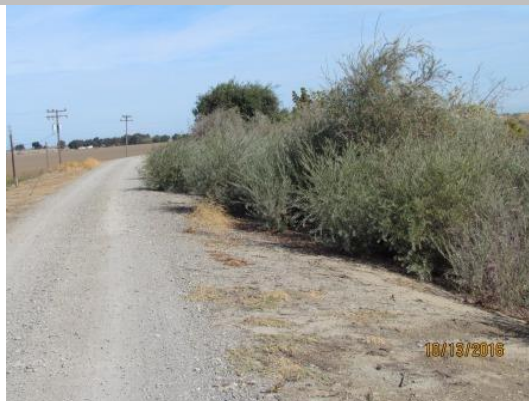
Photo 2 of 2 : SP_2018_RD2089_316_21_20180507_00023.jpg

View of the vegetation on the waterside levee slope. The willows were trimmed back.

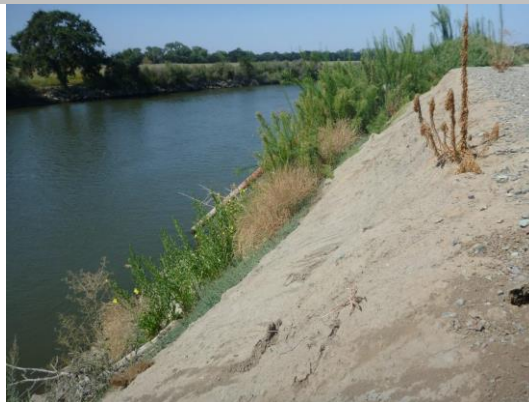
Photo 1 of 3 : LEVAL_SP_2018_511_4301.jpg

LM Start	1.16	Rating **	A/W	Issue No.	30
LM End	1.18	Issue Type +	Ma	Location *	WS
Category	Supplemental			GPS Latitude/Longitude	
				Start	End
Item	2017 Storm Damage			37.805600 °	37.805600 °
				-121.401700 °	-121.401900 °
DWR ID	DWR_RD2089_01_f _ 2017_30				
Comment Code					
Inspector Comment					
Levee Evaluation Comments					
Description:Slope protection repairs are needed along the waterside slope due to erosion and riprap displacement from high water. Based upon levee inspections, it was determined the waterside levee slope is eroding, deteriorating, and degrading. The eroded levee sections need to be restored back to design standards to prevent further deterioration and damage.					
Site ID No:511					
Site Designation:LMA-417					
Repair Type: Erosion					
Rating:Critical					
Field Date:8/16/2017					
Notes: Narrow levee with over steep slope

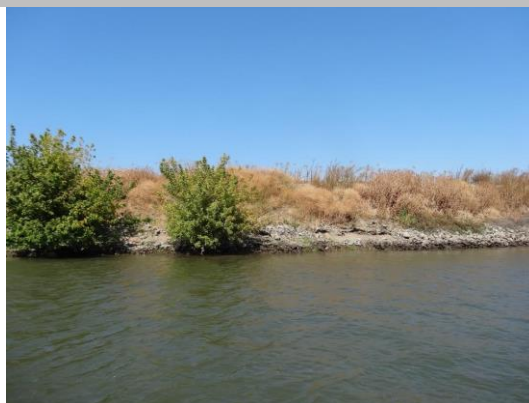
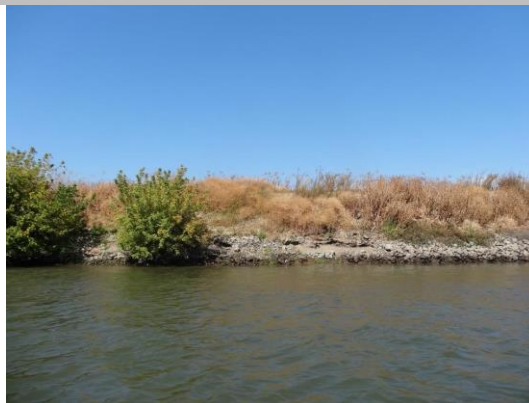
Front view of the erosion.

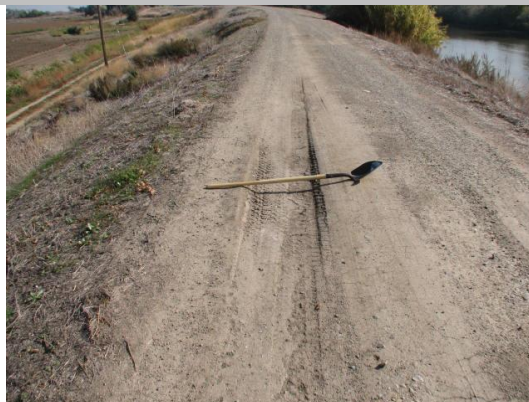
Photo 1 of 1 : SP_2018_RD2089_316_43_20180507_00037.jpg

11/10/2011 Depression in roadway.

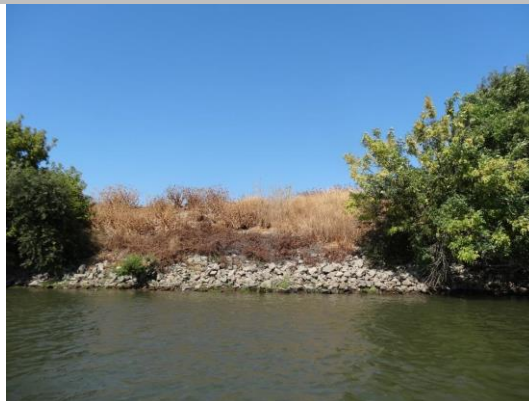
Photo 1 of 2 : SP_2018_RD2089_316_2_20180507_00002.jpg

LM Start	1.23	Rating **	M	Issue No.	2
LM End	1.24	Issue Type +	Ma	Location *	WS
Category	Supplemental			GPS Latitude/Longitude	
				Start	End
Item	DWR Erosion Survey			37.805580 °	37.805580 °
				-121.403010 °	-121.403010 °
DWR ID	RD2089U01RM29.04				
Comment Code					
Inspector Comment					
09/13/2017: No significant change observed. More vegetation observed at the site.					
09/16/2016: The river was not navigable near the site due to the dense water grass, so the site was visited by land survey. No significant change observed.					
06/25/2015: No significant change observed.					
07/02/2014: No significant change observed.					
08/13/2013: The erosion is around a tree at the levee toe. Dense vegetation is visible. [2017 Site ID:RD2089U01RM29.04]

Front view of the erosion.

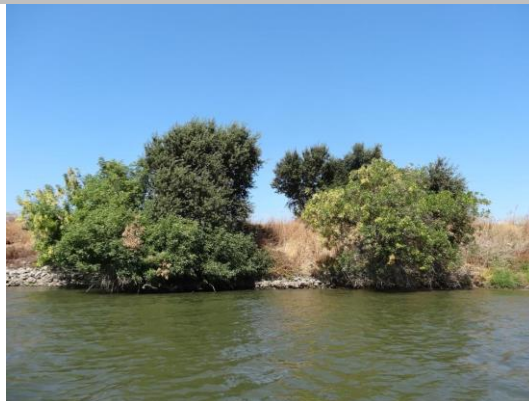
Photo 2 of 2 : SP_2018_RD2089_316_2_20180507_00003.jpg

Close view of the erosion.

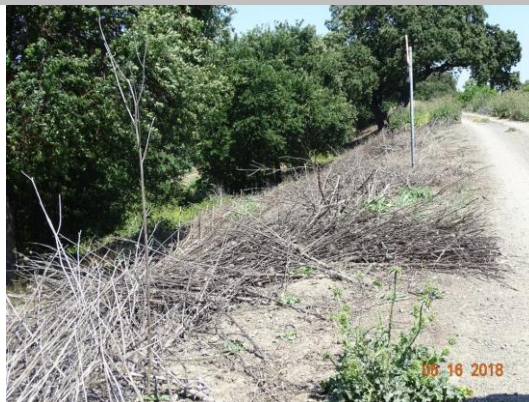
Photo 1 of 1 : SP_2018_RD2089_316_37_20180516_00058.jpg

View of wild growth on the landside slope. Spring 2018.

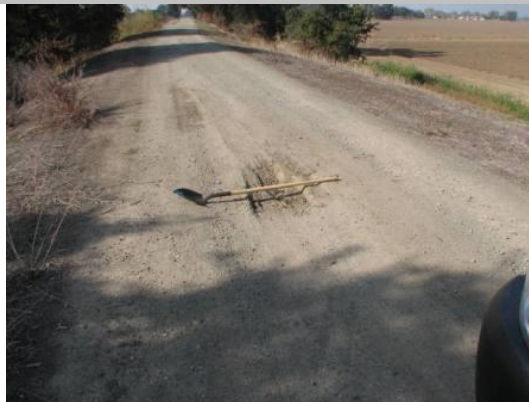
Photo 1 of 1 : SP_2018_RD2089_316_45_20180507_00039.jpg

11/10/2011 Roadway depression.

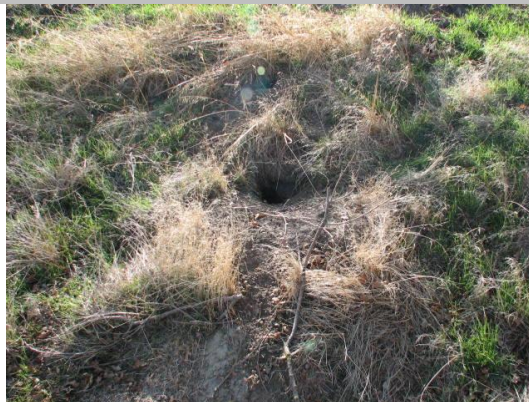
Photo 1 of 1 : SP_2018_RD2089_316_47_20180507_00040.jpg

11/10/2011 Active rodent burrow on landside slope.

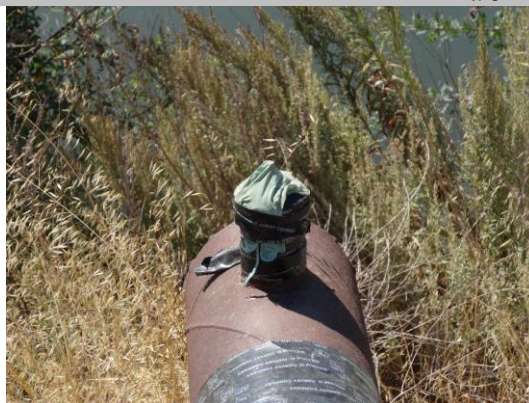
Photo 2 of 3 : UCIP_SP_2018_21585_36623.jpg

LM Start	1.41	Rating **	M	Issue No.	961
LM End	1.41	Issue Type +	Ma	Location *	
Category	Supplemental			GPS Latitude/Longitude	
				Start	End
Item	DWR UCIP LMA Responsibility			37.806323 °	37.806323 °
				-121.406155 °	-121.406155 °
DWR ID					
Comment Code					
Inspector Comment					
FS_ID:21585 DS_ID:23045 EP_NO: N/A Repair Type: Non-Urgent Crossing Status: Found UCIP Comments: - siphon breaker needs repair. FIELD_STRUCT_DESC: 10-inch steel drainage discharge pipe through the levee, 2.4 feet below the crown. Pump in a drainage ditch on the landside (LS). Siphon breaker on the waterside (WS) shoulder. [Additional Reference(s): DWR Levee Log, 1991]. FS Date: 9/12/2013

WS view: exposed steel pipe with siphon breaker. Looks siphon breaker needs repair.

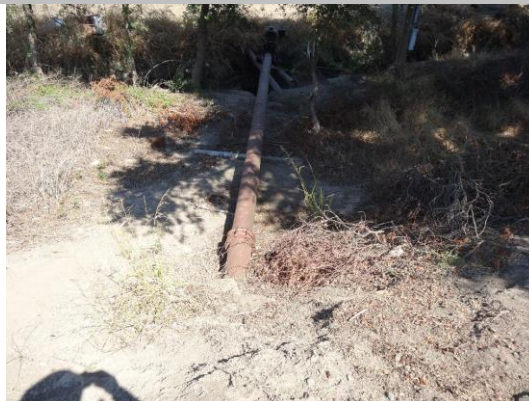
Photo 3 of 3 : UCIP_SP_2018_21585_36622.jpg

LM Start	1.41	Rating **	M	Issue No.	961 (cont)	
LM End	1.41	Issue Type +	Ma	Location *		
Category	Supplemental			GPS Latitude/Longitude		
				Start	End	
Item	DWR UCIP LMA Responsibility			37.806323 °	37.806323 °	
				-121.406155 °	-121.406155 °	
DWR ID						
Comment Code						
Inspector Comment						
FS_ID:21585 DS_ID:23045 EP_NO: N/A Repair Type: Non-Urgent Crossing Status: Found UCIP Comments: - siphon breaker needs repair. FIELD_STRUCT_DESC: 10-inch steel drainage discharge pipe through the levee, 2.4 feet below the crown. Pump in a drainage ditch on the landside (LS). Siphon breaker on the waterside (WS) shoulder. [Additional Reference(s): DWR Levee Log, 1991]. FS Date: 9/12/2013

LS view: exposed steel pipe on levee slope.

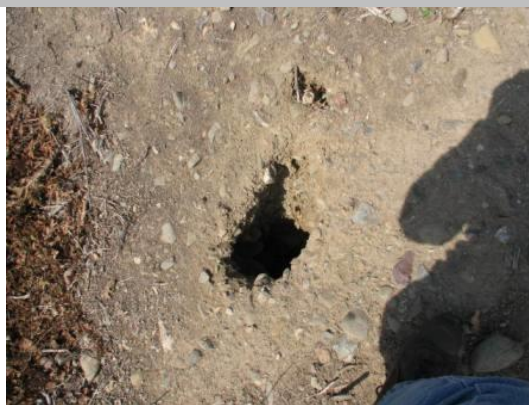
Photo 1 of 1 : SP_2018_RD2089_316_49_20180507_00041.jpg

11/10/2011 Deep burrow on waterside.

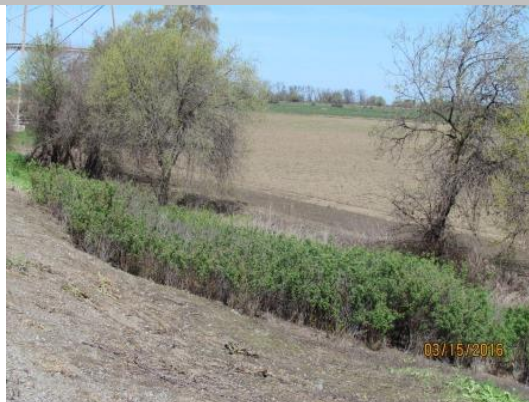
Photo 1 of 1 : SP_2018_RD2089_317_20_20180507_00022.jpg

View of the vegetation on the landside levee slope.

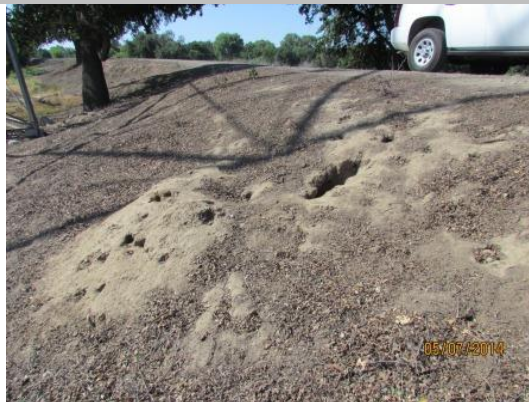
Photo 1 of 1 : SP_2018_RD2089_317_48_20180507_00053.jpg

View of the rodent burrow on the landside levee slope.

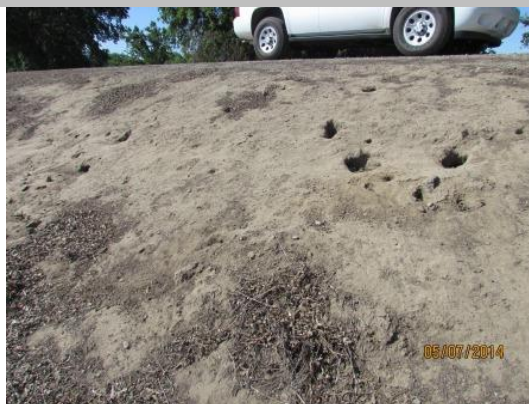
Photo 1 of 1 : SP_2018_RD2089_317_49_20180507_00054.jpg

LM Start	0.21	Rating **	M	Issue No.	49
LM End	0.21	Issue Type +	Ma	Location *	LS
Category	Earthen Levee			GPS Latitude/Longitude	
				Start	End
Item	Animal Control			37.809148 °	37.809148 °
				-121.409897 °	-121.409897 °
DWR ID	DWR_RD2089_02_s_2018_49				
Comment Code					
A3 : No rodents visible, but rodent burrows visible; need to backfill and compact or grout burrows.					
Inspector Comment

View of the multiple rodent burrows on the landside levee hinge and slope.

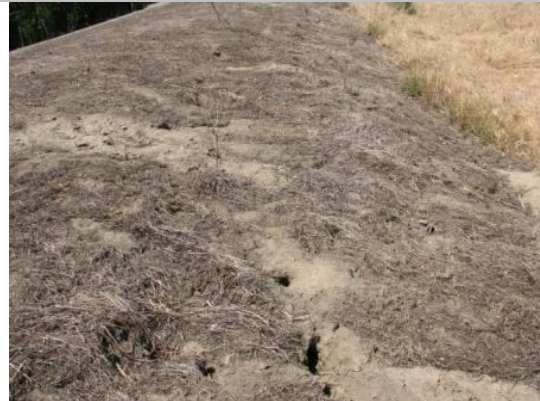
Photo 1 of 1 : SP_2018_RD2089_317_24_20180507_00024.jpg

05/24/2011 Active burrows, ground squirrel sighted in area.

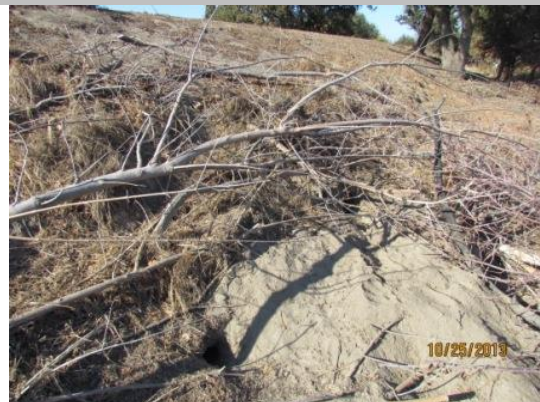
Photo 1 of 1 : SP_2018_RD2089_317_51_20180507_00058.jpg

View of the rodent burrow on the landside levee toe.

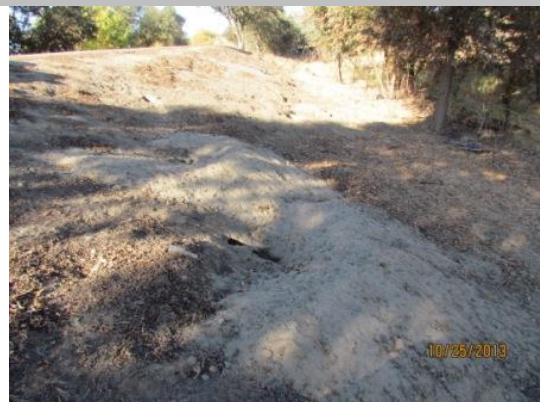
Photo 1 of 3 : SP_2018_RD2089_317_53_20180507_00060.jpg

View of the multiple rodent burrows on the landside levee slope.

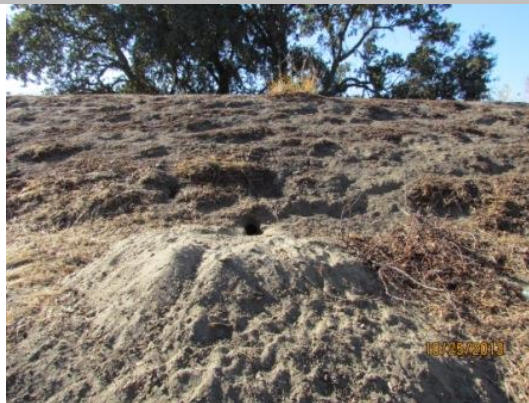
Photo 2 of 3 : SP_2018_RD2089_317_53_20180507_00061.jpg

View of the rodent burrow on the landside levee slope.

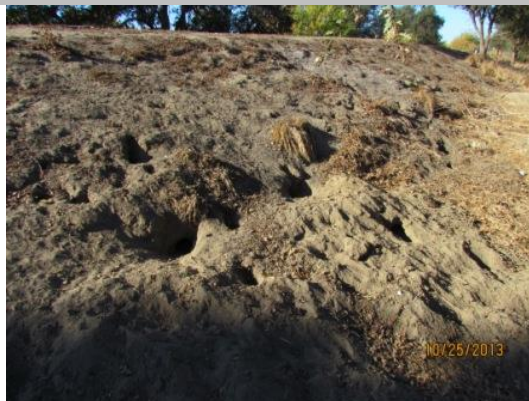
Photo 3 of 3 : SP_2018_RD2089_317_53_20180507_00062.jpg

Another view of the multiple rodent burrows on the landside levee slope.

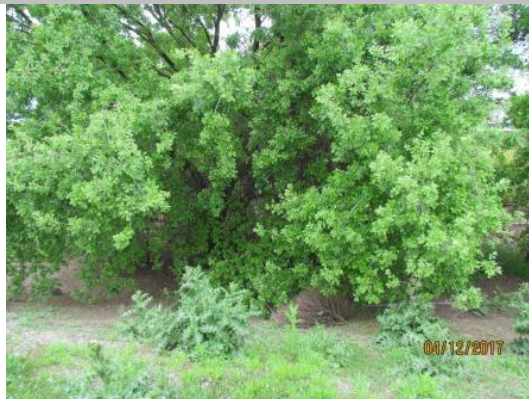
Photo 1 of 1 : SP_2018_RD2089_317_55_20180507_00064.jpg

LM Start	0.34	Rating **	M	Issue No.	55
LM End	0.34	Issue Type +	Ma	Location *	LS
Category	Earthen Levee			GPS Latitude/Longitude	
				Start	End
Item	Trim / Thin Trees			37.810052 °	37.810052 °
				-121.411966 °	-121.411966 °
DWR ID	DWR_RD2089_02_s_2017_55				
Comment Code					
T1 : Trim trees to at least five feet above ground level.					
Inspector Comment

View of the overgrown tree on the levee slope.

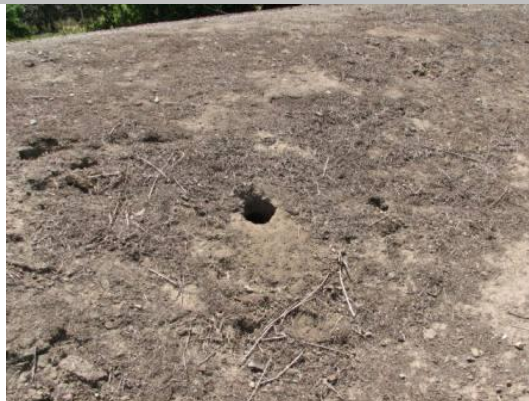
Photo 1 of 1 : SP_2018_RD2089_317_26_20180507_00025.jpg

05/24/2011 Active rodent burrow.

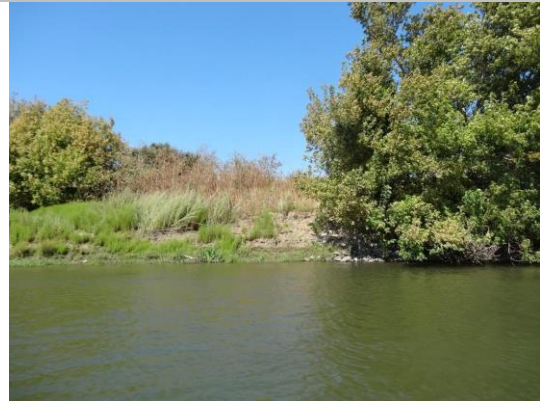
Photo 1 of 3 : SP_2018_RD2089_317_1_20180507_00001.jpg

Front view of the site.

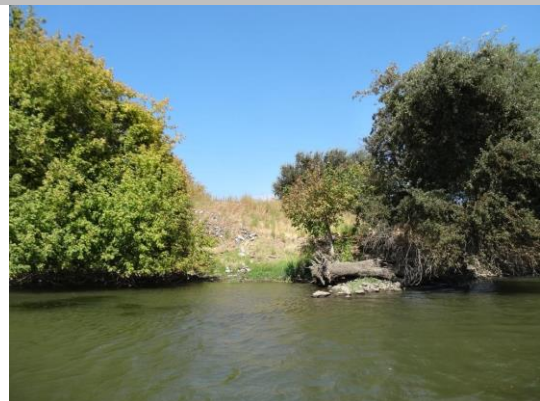
Photo 2 of 3 : SP_2018_RD2089_317_1_20180507_00002.jpg

Close view of the erosion.

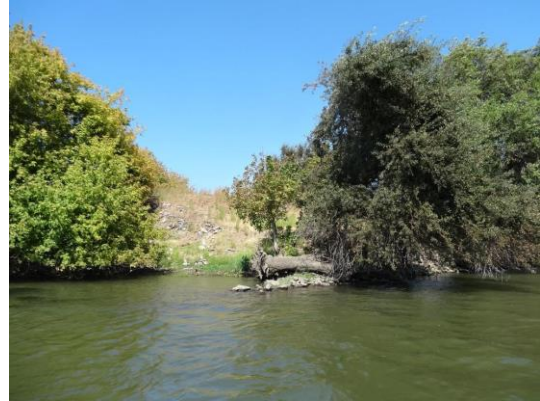
Photo 3 of 3 : SP_2018_RD2089_317_1_20180507_00003.jpg

Close view of the erosion.

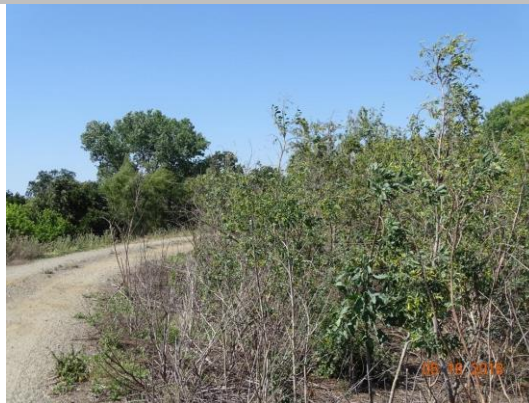
Photo 1 of 1 : SP_2018_RD2089_317_62_20180516_00072.jpg

View of wild growth on the partially visible landside slope. Spring 2018.

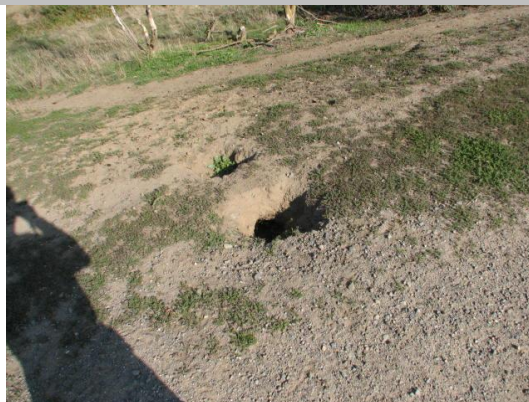
Photo 1 of 1 : SP_2018_RD2089_317_13_20180507_00015.jpg

11/10/2011 Two large burrows on crown, need to be filled.

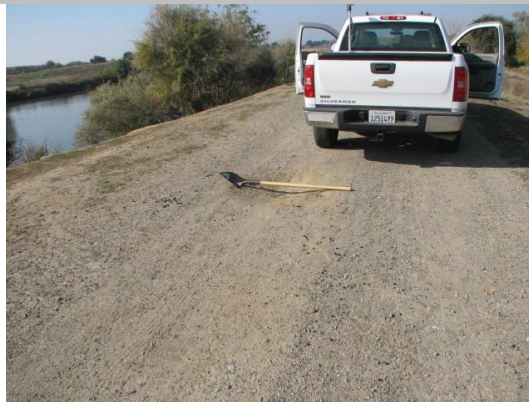
Photo 1 of 1 : SP_2018_RD2089_317_10_20180507_00011.jpg

11/10/2011 Depression in crown needs to be filled.

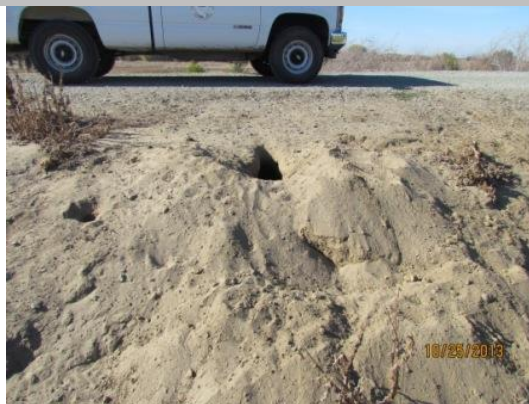
Photo 1 of 1 : SP_2018_RD2089_317_54_20180507_00063.jpg

View of the rodent burrow on the landside levee slope.

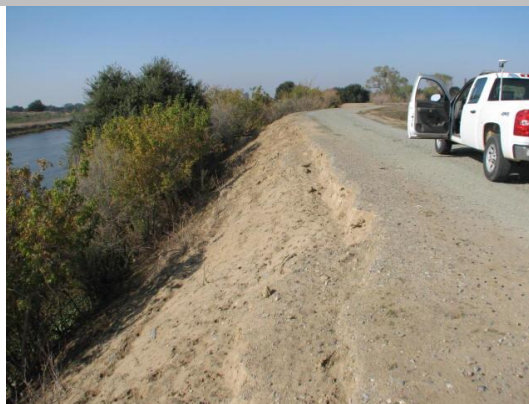
Photo 1 of 1 : SP_2018_RD2089_317_14_20180507_00016.jpg

11/10/2011 Approximately 1' scarp has been created by livestock travel.

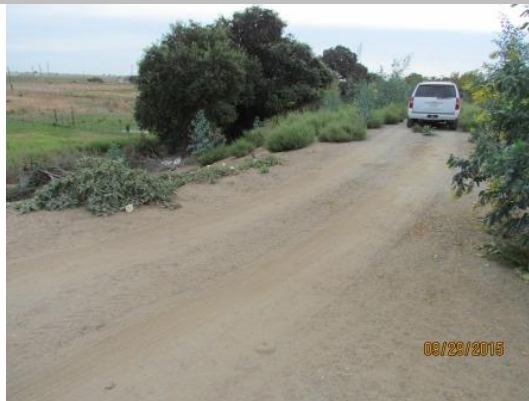
Photo 1 of 4 : SP_2018_RD2089_317_35_20180507_00031.jpg

View of the levee crown depression looking upstream.

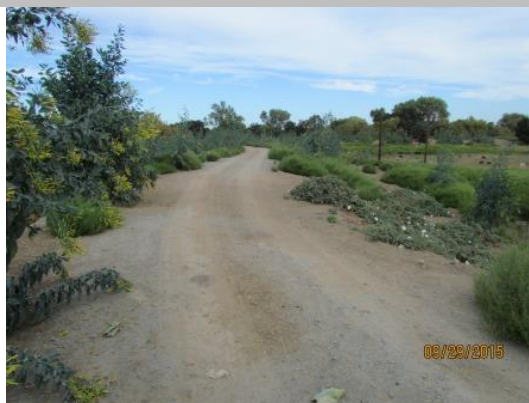
Photo 2 of 4 : SP_2018_RD2089_317_35_20180507_00032.jpg

View of the levee crown depression looking downstream.

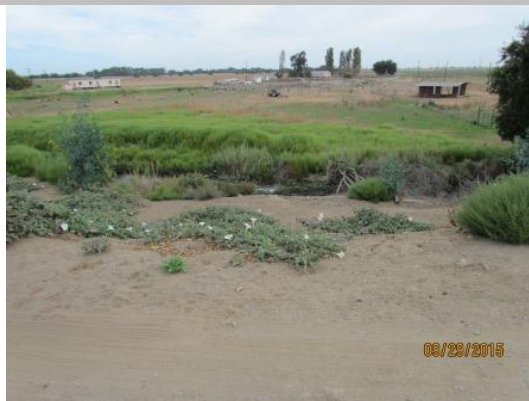
Photo 3 of 4 : SP_2018_RD2089_317_35_20180507_00033.jpg

View of the levee crown depression looking to the landside.

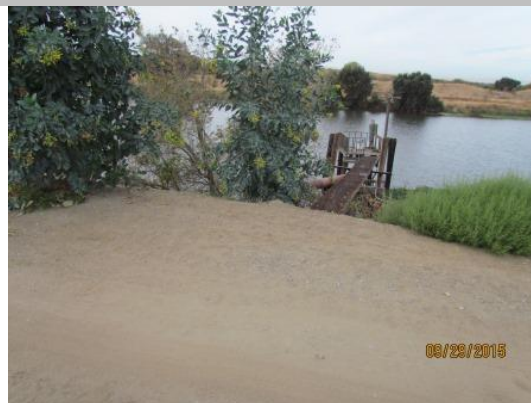
Photo 4 of 4 : SP_2018_RD2089_317_35_20180507_00034.jpg

View of the levee crown depression looking to the waterside.

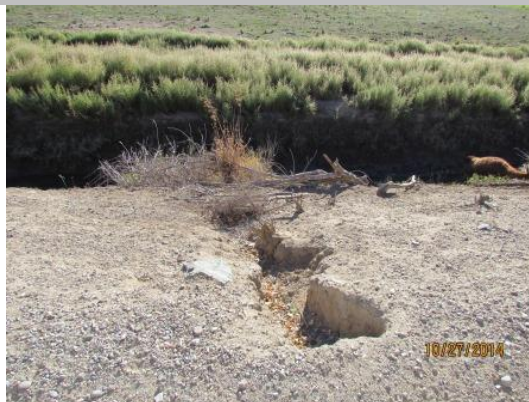
Photo 1 of 1 : SP_2018_RD2089_317_15_20180507_00017.jpg

View of the scour from surface runoff on the landside levee slope.

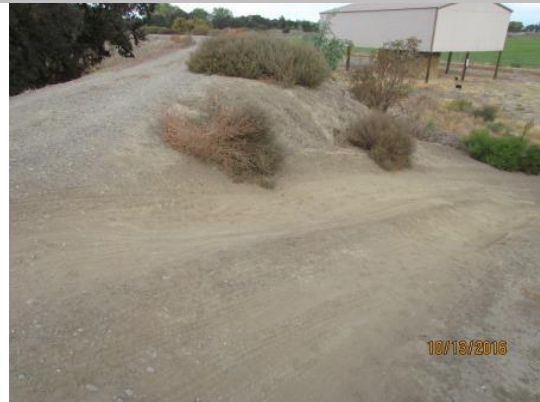
Photo 1 of 1 : SP_2018_RD2089_317_42_20180507_00043.jpg

View of the ramp on the landside levee slope.

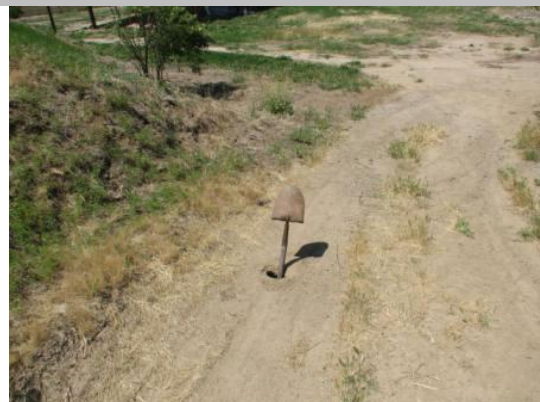
Photo 1 of 3 : SP_2018_RD2089_317_40_20180507_00039.jpg

05/24/2011 Deep vertical burrow in ramp on land side of levee.

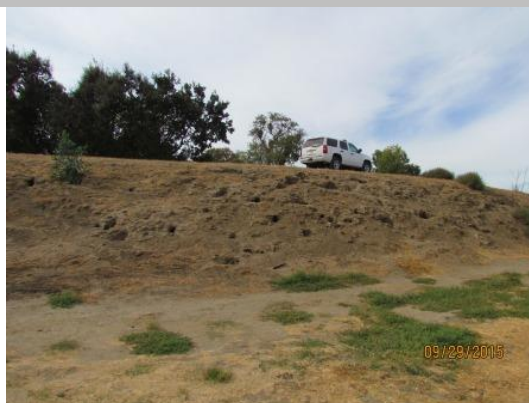
Photo 3 of 3 : SP_2018_RD2089_317_40_20180507_00041.jpg

View of the multiple rodent holes on the landside levee slope.

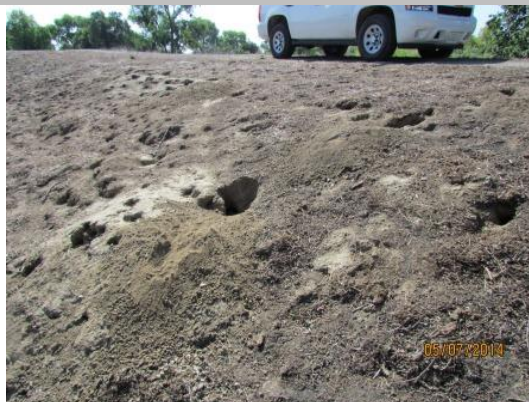
Photo 1 of 1 : SP_2018_RD2089_317_5_20180507_00005.jpg

View of the rodent holes on the landside levee slope.

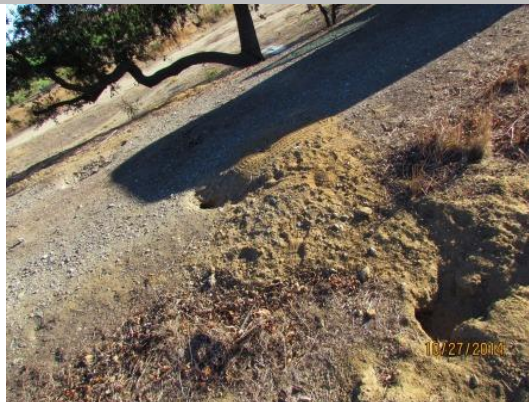
Photo 1 of 2 : SP_2018_RD2089_317_12_20180507_00013.jpg

View of several large rodent holes on the levee crown.

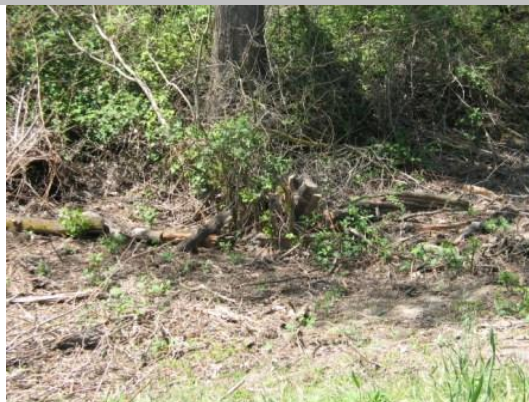
Photo 1 of 1 : SP_2018_RD2089_317_29_20180507_00028.jpg

Tree stump >2" left after vegetation and tree removal.

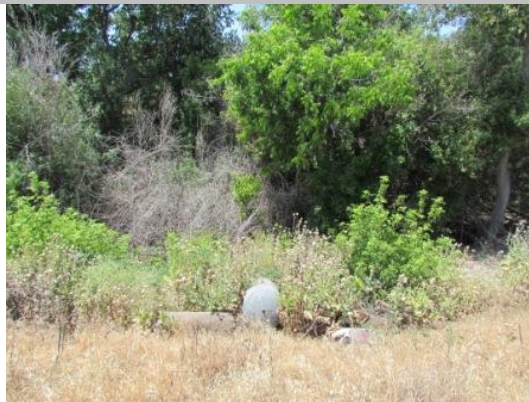
Photo 1 of 1 : SP_2018_RD2089_317_17_20180507_00019.jpg

View of water tanks disposed on waterside slope.

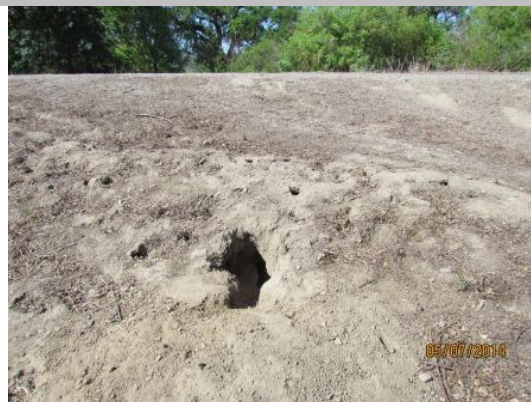
Photo 1 of 1 : SP_2018_RD2089_317_6_20180507_00006.jpg

View of the large rodent hole on the landside levee slope.

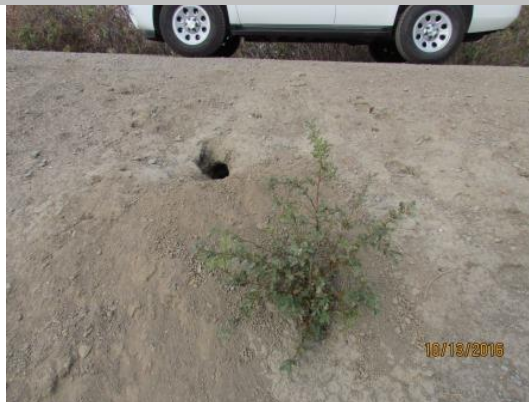
Photo 1 of 1 : SP_2018_RD2089_317_28_20180507_00027.jpg

View of the rodent burrow in the landside levee slope.

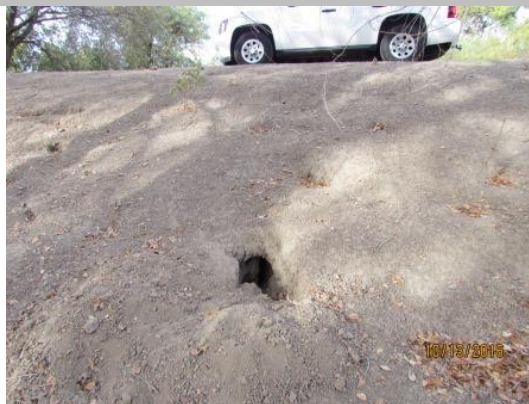
Photo 1 of 1 : SP_2018_RD2089_317_19_20180507_00021.jpg

View of the rodent burrow in the landside levee slope.
